Profiling for successful BGA/CSP Rework

This paper discusses how to successfully profile a printed circuit board when reworking Ball Grid Array and Chip Scale Packages.

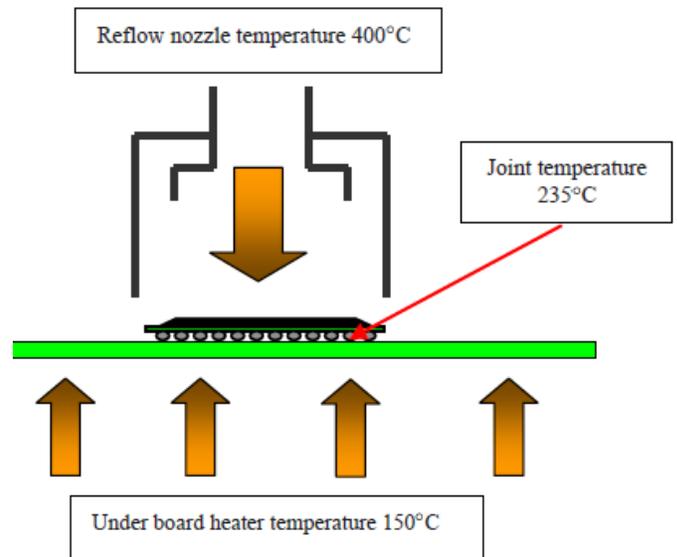
Example 1

On any reflow soldering system that heats both sides of the PCB assembly, the required solder joint temperature is a function of how much heat is applied to both the top and bottom side. It is quite possible to achieve the same solder joint temperature with a number of heat settings. The following 2 examples illustrate this.

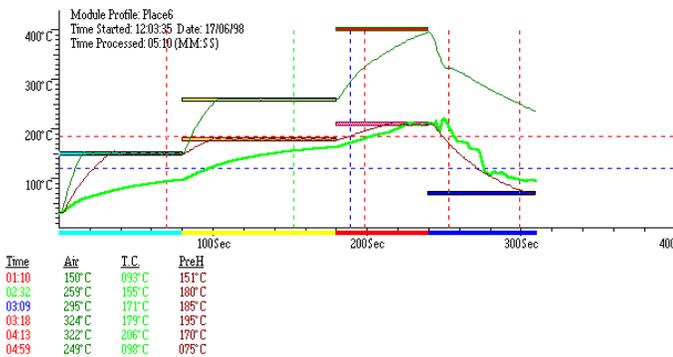
The graph below shows a trace of a profile taken from under a 492 PBGA on a PC motherboard where the thermocouple trace appears to be normal – hitting the desired pre-heat, soak and reflow temperatures. In this case with either solder paste or flux, a very low pass rate was achieved.

The second graph shown is the final profile that was used, and as you can see, the 2 traces are very similar but the heating has been done in a totally different way. In this case, we have increased the number of zones to 4, reduced the top air temperature significantly while increasing the underboard heat to the whole board and utilizing an underboard centralized heating zone.

The route of the yield problems was due to the plastic BGA warping during reflow. An excessive source temperature on the topside of the PCB caused this.

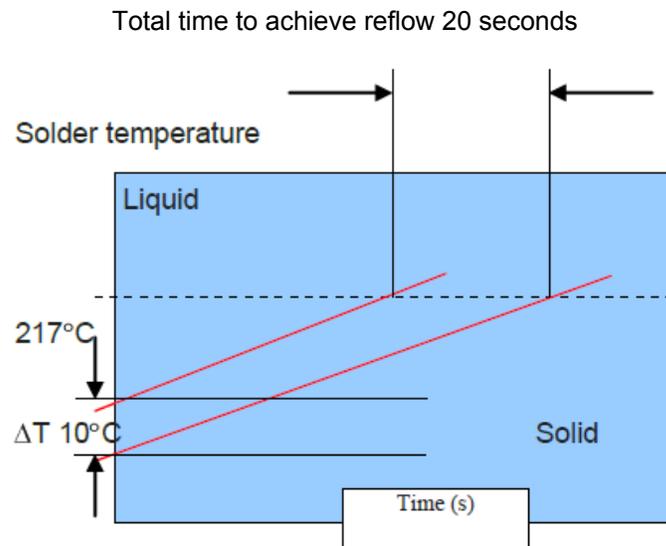
Graph of ramp rate at 0.5C/Sec

The following diagram shows a graph section of a component’s solder joints going from solid to liquid at a melting temperature of 217C. We are assuming that the achieved T across the component is 10C.

The rate of temperature rise (ramp rate) will determine the duration of reflow from start to finish. This is directly proportional to the input temperatures set on the profile. In this case the ramp rate is 0.5C per second.

Solder reflows on one side first causing solder shorts

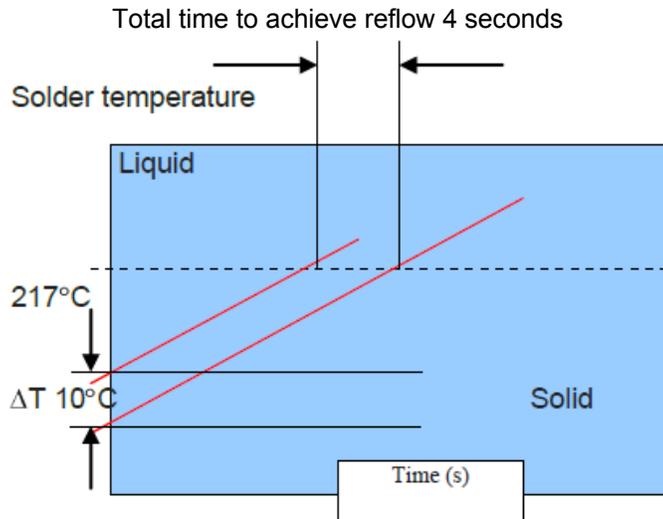
Graph of ramp rate at 2.5C/Sec

The solution would involve changing the profile input-temperatures to achieve a higher ramp rate. This would in turn produce a more simultaneous reflow as illustrated in the graph below.
