Debugging a Mixed Signal Design with a Tektronix Mixed Signal Oscilloscope

Introduction

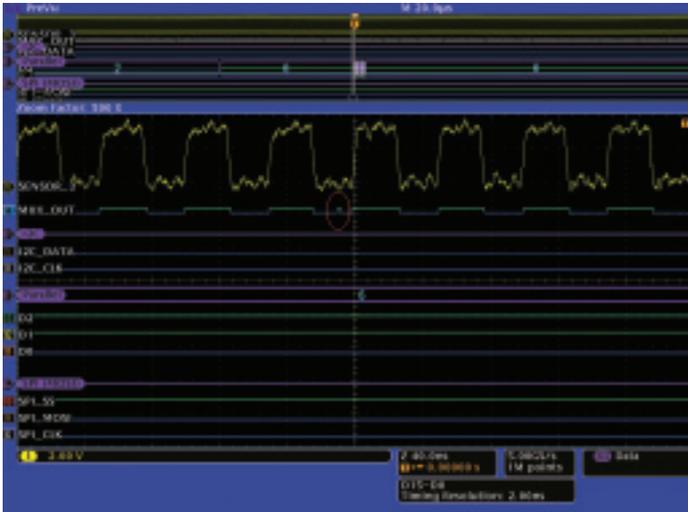
Figure 6. Wave Inspector[®] reveals a glitch on the MUX_OUT signal.

Figure 6 shows the timing correlation between the analog and digital channels in the MSO Series. The input to the MUX is displayed on CH1 (SENSOR_3) while the MUX output is observed on digital channel D14 (MUX_OUT). The engineer noticed that although the MUX output had a glitch, the input to the MUX appeared glitch free. After identifying the glitch with the digital channel, the engineer decided to take a closer look by connecting CH2 to the MUX output. Figure 7 shows the resulting acquisition with the MSO Series still configured to trigger on the parallel bus value 0x7. The waveforms for the

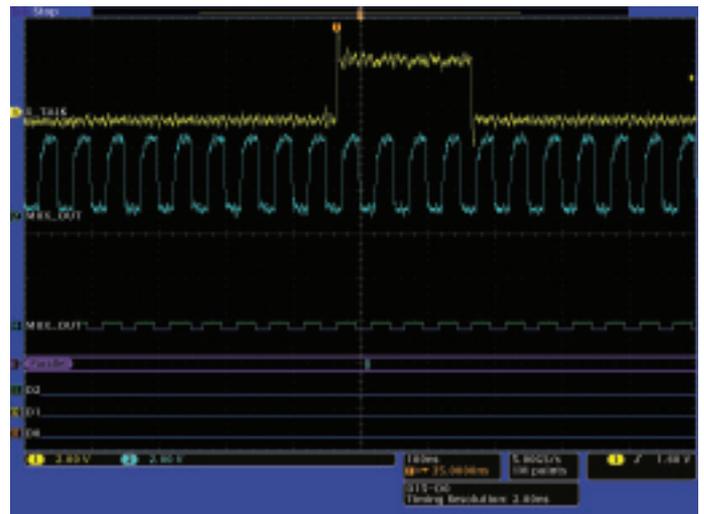
Figure 9. The PCB modification removes the crosstalk.

After spending some time to reroute the offending signal on the circuit board, the engineer configured the MSO Series to trigger on CH1. Figure 9 shows that the MSO Series triggered on the CH1 transition, but does not show a glitch on the MUX_OUT signal. Since the MUX_OUT signal did not have a glitch present, the parallel bus did not produce an error condition. The circuit board modification removed the crosstalk, and allowed the embedded design engineer to complete his system evaluation.
