# Debugging a mixed-signal embedded design with the Tektronix MSO4000 Series Mixed Signal Oscilloscope

## Introduction

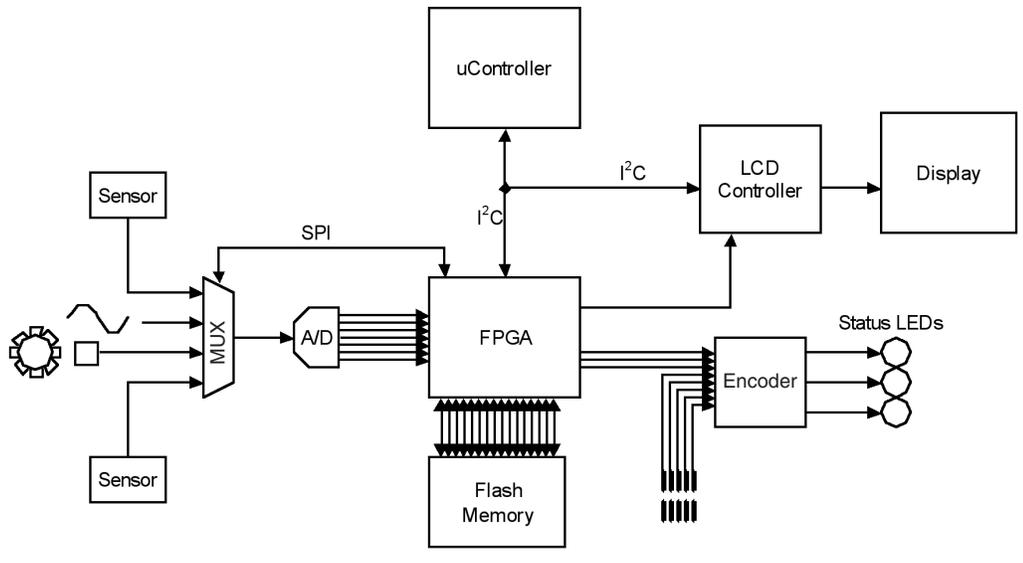
► **Figure 1.** Simplified Acquisition / Instrumentation System

Microprocessors, FPGAs, Analog-to-Digital Converters (ADC), and Digital-to-Analog Converters (DAC) are all examples of ICs that present unique measurement challenges in today's embedded designs. The engineer may need to decode a SPI bus between two ICs while observing the input and output of an ADC at the same time, on the same system board. An example of such a mixed-signal system is shown in Figure 1.

Debugging the hardware shown in Figure 1 is a difficult and somewhat daunting task to the engineer who is armed with his favorite 4 channel oscilloscope. Many engineers feel comfortable with their oscilloscope, and in the interest of saving time, may choose to acquire 3 or 4 oscilloscopes in order to probe multiple signals at once. Logic analyzers provide the ability to probe many digital signals, but the complexity of the debug task may not merit the setup and learning curve required to use the logic analyzer. Fortunately for engineers faced with this task, there is a new instrument available from Tektronix called a Mixed Signal Oscilloscope (MSO) that addresses their needs. The Tektronix MSO4000 Series combines the basic functionality of a 16-channel logic analyzer with the trusted performance of a 4-channel Tektronix oscilloscope. This application note demonstrates the industry-leading capabilities of the Tektronix MSO4000 by walking through the debug of a mixed-signal embedded design.

During the initial debug of the system (shown in Figure 1), the system occasionally encountered a condition where the status LEDs on the circuit board indicated a failure. The ambiguous error reported by the status LEDs left the system engineer unsure if the problem was hardware or software related. A similar error had previously been the result of poor signal quality at the input of the analog MUX, but the hardware that caused the signal fidelity problem had been successfully replaced. Since the system engineer was suspicious that the error could be coming from a source other than the MUX input, he decided to get a broad system view by probing the analog input to the MUX as well as several digital buses. With 4 analog and 16 digital channels available for debugging, the MSO4000 was connected to the signals labeled 1-4 in Figure 2.

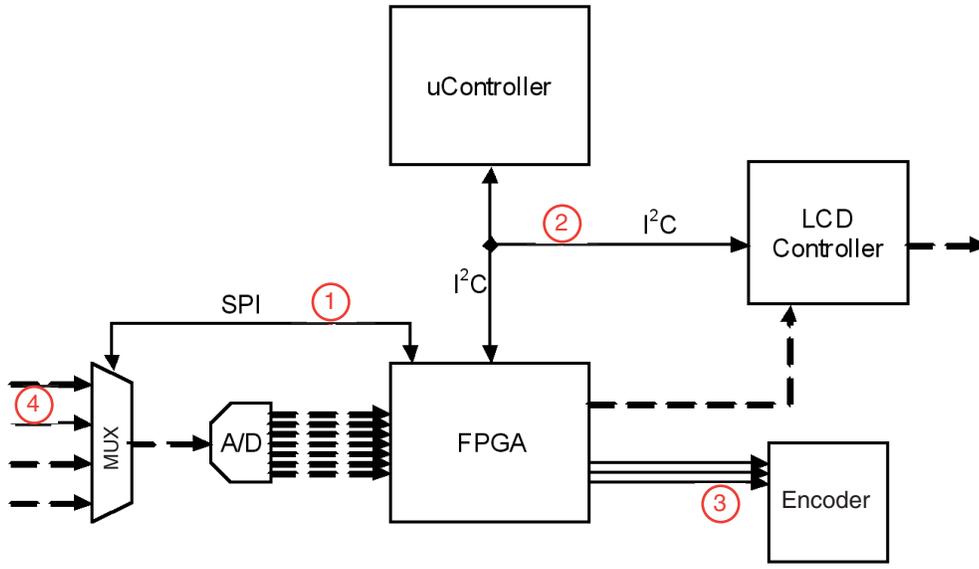
► **Figure 2.** Subset of acquisition system with probe points.

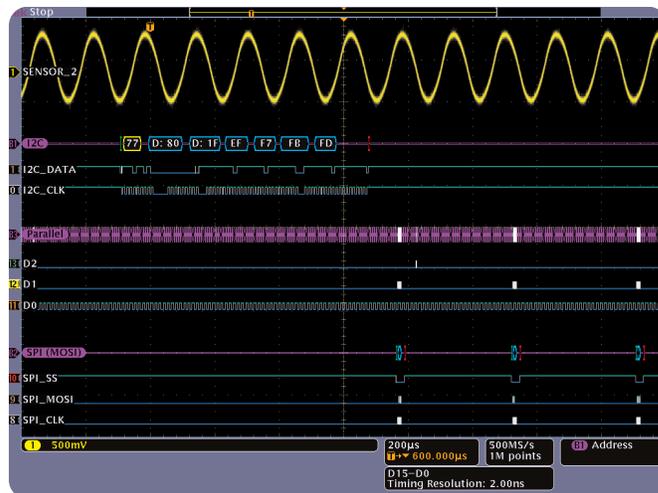
► **Figure 3.** MSO4000 displaying I<sup>2</sup>C, SPI, and parallel buses with CH1 analog.

Figure 3 shows a screenshot from the MSO4000 probing the SPI bus (1), I<sup>2</sup>C bus (2), 3-bit parallel bus (3), and analog input (4) at the same time. Since the error could be isolated to a particular subroutine, the MSO4000 was configured to take a single acquisition that triggered on particular I<sup>2</sup>C activity. Setting the record length to 1M points guaranteed that all the useful information around the event on the I<sup>2</sup>C bus would be accurately captured. The engineer ran the subroutine and quickly referred to the MSO4000 to see what had happened in the system. The clean analog waveform at the input of the MUX shown on CH1 confirmed the engineer's suspicion that the hardware had been fixed, and the error was occurring elsewhere. The MSO4000 triggered on and decoded the I<sup>2</sup>C data being written from the microprocessor. The engineer noticed activity on the SPI bus and the displayed signals labeled D1 and D2 shortly after the I<sup>2</sup>C data was transmitted. The activity on these buses was suspicious because the executed function was supposed to primarily involve the LCD controller. Because the MSO4000 had already decoded the value of the I<sup>2</sup>C data, the engineer could see that the microprocessor had written I<sup>2</sup>C data to address 0x77. Address 0x77 is the address of the FPGA, but the subroutine was supposed to write data to address 0x76 instead, which is the address of the LCD controller.

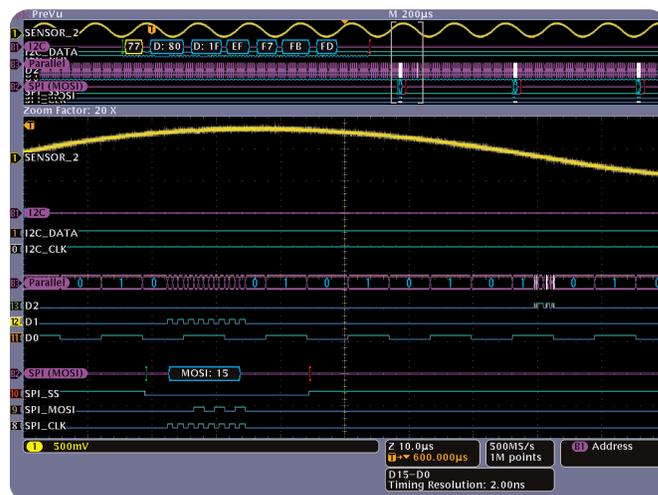
► **Figure 4.** Wave Inspector is used to zoom in and show packet detail.

Figure 4 shows the same acquisition while using Wave Inspector® to zoom in on the details of the SPI and parallel buses. The SPI data is decoded on screen as a write from the master (FPGA) to the slave (MUX) with a data value of 0x15. This SPI command instructed the input MUX to change the input it was using for the signal path. This unexpected change in the input signal caused the FPGA to send an error code to the status LEDs on the parallel bus. The activity on signal D2 indicating the error code and the decoding of the parallel bus can be observed in Figure 4 as well. The embedded design engineer was quickly able to determine that a software bug had caused the

malfunction in the system because the MSO4000 was able to view and decode all the signals of interest simultaneously. The software programmer had mistakenly written I<sup>2</sup>C data from the microcontroller to the FPGA when the packet was intended for the LCD controller.

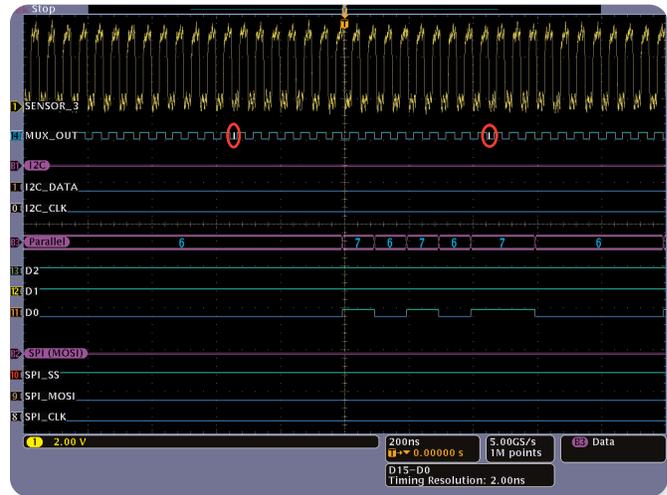
► **Figure 5.** The white edges on MUX\_OUT indicate more details are present.

At first glance, the signals shown in Figure 5 appear to be well behaved, but the system engineer quickly identified two edge transitions on the MUX\_OUT signal that appeared unique. The white transitions on the MUX\_OUT signal shown in Figure 5 are an indication to the user that more information exists within those portions of the signal. The MSO4000's multiple edge detection capability highlights areas of the waveform where zooming may reveal higher frequency digital pulses. Figure 6 reveals the details behind the first white transition when Wave Inspector is used to zoom in on the waveform details. The portion of the signal that was drawn as the white transition in Figure 5 is actually a glitch on the MUX\_OUT signal.

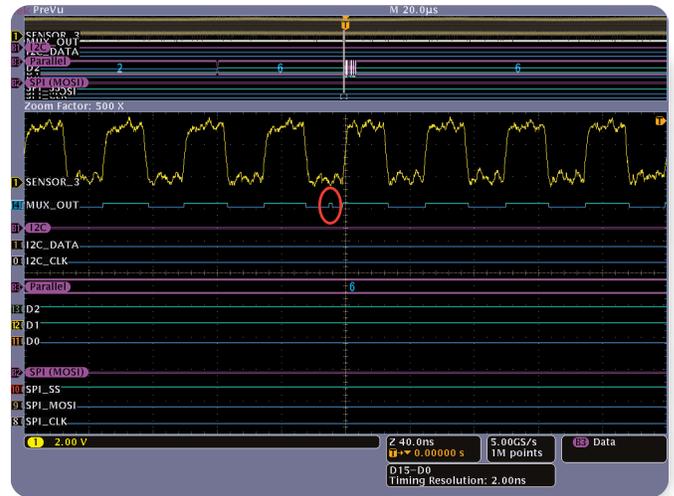
► **Figure 6.** Wave Inspector reveals a glitch on the MUX\_OUT signal.

Figure 6 shows the timing correlation between the analog and digital channels in the MSO4000. The input to the MUX is displayed on CH1 (SENSOR\_3) while the MUX output is observed on digital channel D14 (MUX\_OUT). The engineer noticed that although the MUX output had a glitch, the input to the MUX appeared glitch free. After identifying the glitch with the digital channel, the engineer decided to take a closer look by connecting CH2 to the MUX output. Figure 7 shows the resulting acquisition with the MSO4000 still configured to trigger on the parallel bus value 0x7. The waveforms for the SPI and I<sup>2</sup>C buses have been turned off in Figure 7 to focus on the primary signals of interest. Using the analog probes on the MUX input and output revealed that glitches present on the output are not present on the input signal. Figure 7 shows that a glitch on the MUX\_OUT signal appeared a short time before the FPGA sent the error code. The timing relationship between these two signals indicated that the glitch could be the problem the engineer had observed. The engineer repeated the acquisition several times with the same configuration, and observed behavior similar to Figure 7 in every case.

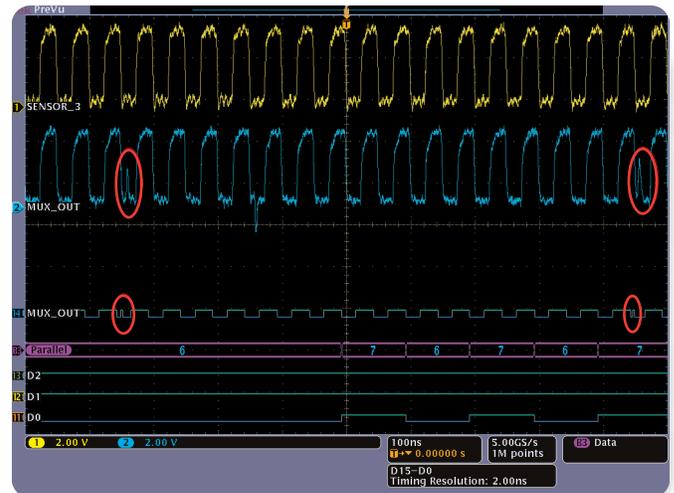
► **Figure 7.** CH2 shows more detail for MUX\_OUT.

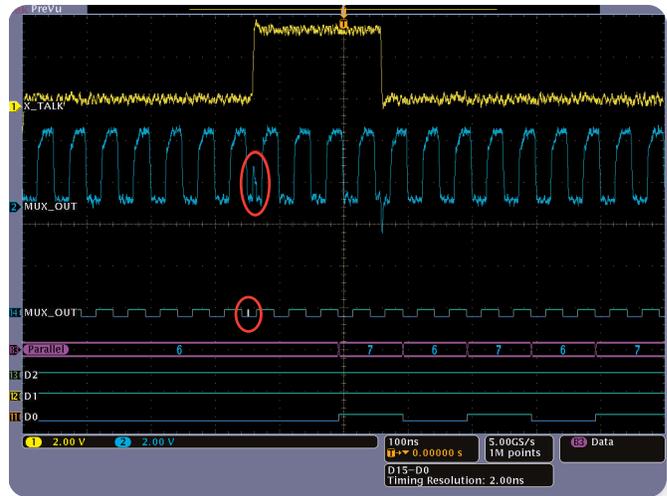
► **Figure 8.** CH1 shows the source of crosstalk into the MUX\_OUT signal.

After studying the screenshots from the MSO4000, the embedded design engineer was suspicious that crosstalk could be the source of the glitch on the MUX\_OUT signal. None of the signals he monitored in Figure 5 were identified as the source of crosstalk. While examining the circuit board layout in more detail, the engineer found a via located next to the MUX\_OUT trace on the printed circuit board (PCB). The engineer probed the via on the PCB with CH1, and waited for another trigger from the parallel bus. The resulting screenshot is shown in Figure 8. Figure 8 shows that a low to high transition for the signal captured on CH1 directly correlates in time with a positive glitch on the MUX\_OUT signal. Correspondingly, the high to low transition directly relates to a negative glitch on the MUX\_OUT signal.

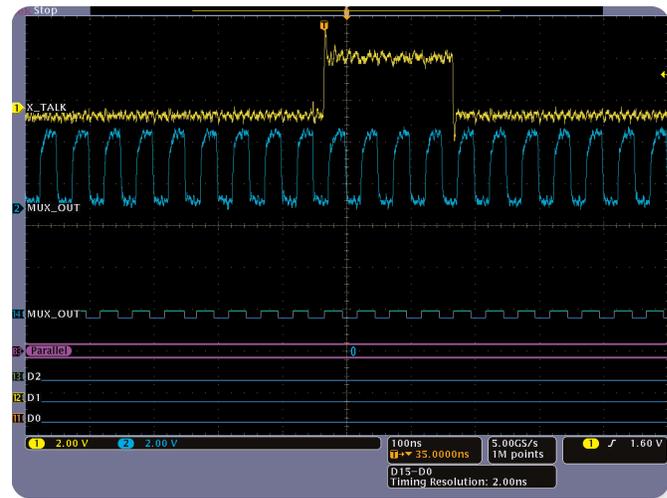
► **Figure 9.** The PCB modification removes the crosstalk.

After spending some time to reroute the offending signal on the circuit board, the engineer configured the MSO4000 to trigger on CH1. Figure 9 shows that the MSO4000 triggered on the CH1 transition, but does not show a glitch on the MUX\_OUT signal. Since the MUX\_OUT signal did not have a glitch present, the parallel bus did not produce an error condition. The circuit board modification removed the crosstalk, and allowed the embedded design engineer to complete his system evaluation.
