Connecting Streamline Series VNA with Thunderbolt 3 PC

Keysight Technologies

Troubleshooting – Connection of Host PC and VNA

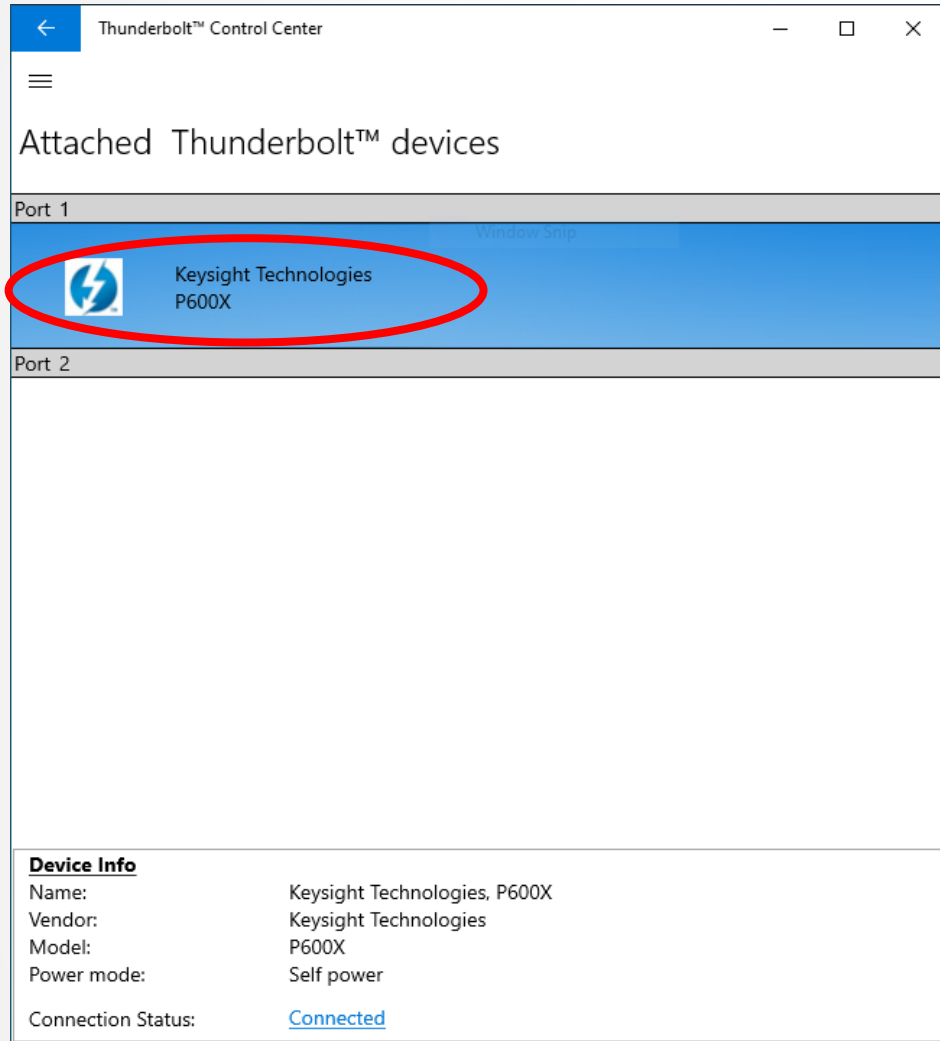
1. Is your VNA identified with Thunderbolt Control Center?

- If VNA is connected correctly, “P600x” (chassis of Streamline Series VNA) will be shown.

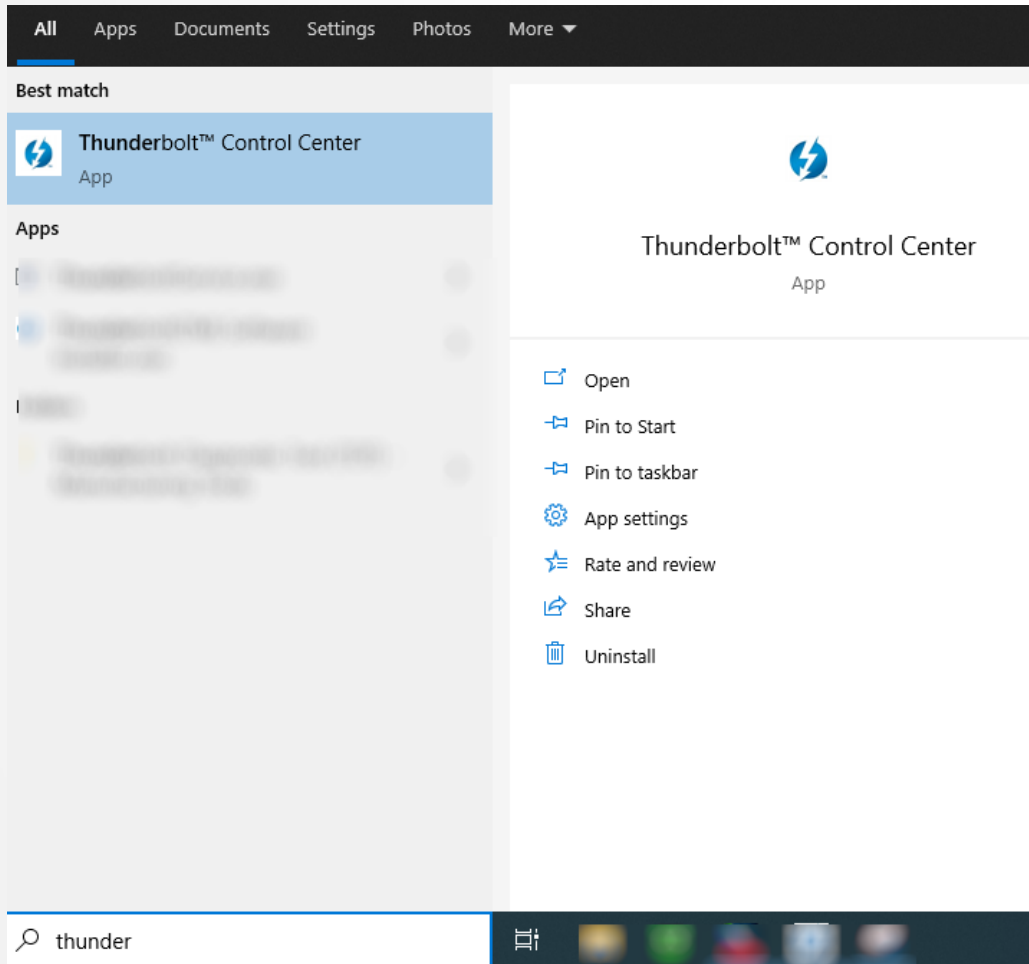
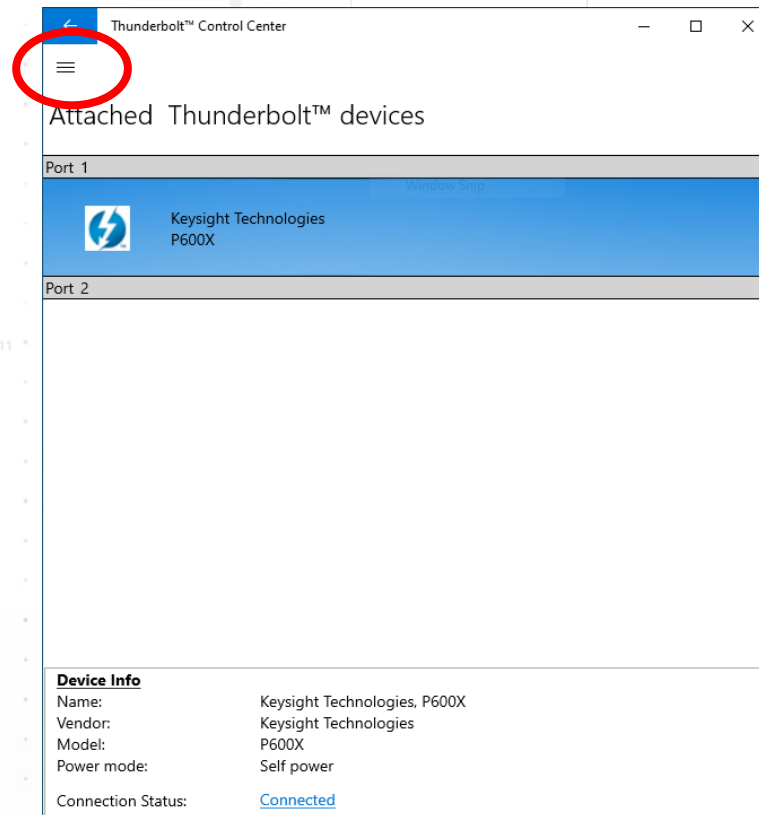
2. What is the revision of Thunderbolt Control Center?

- Type in “Thunderbolt..” in the Windows search bar
- Select “Thunderbolt Control Center” to launch
- Click three-bar icon and identify the revision of Thunderbolt Control Center

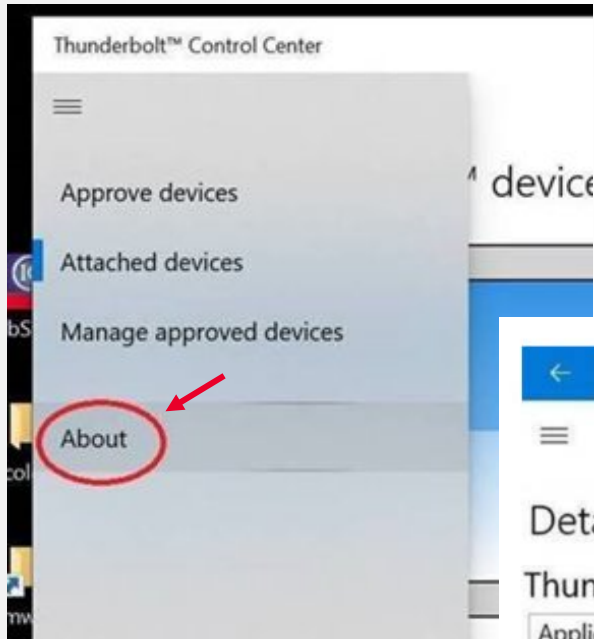
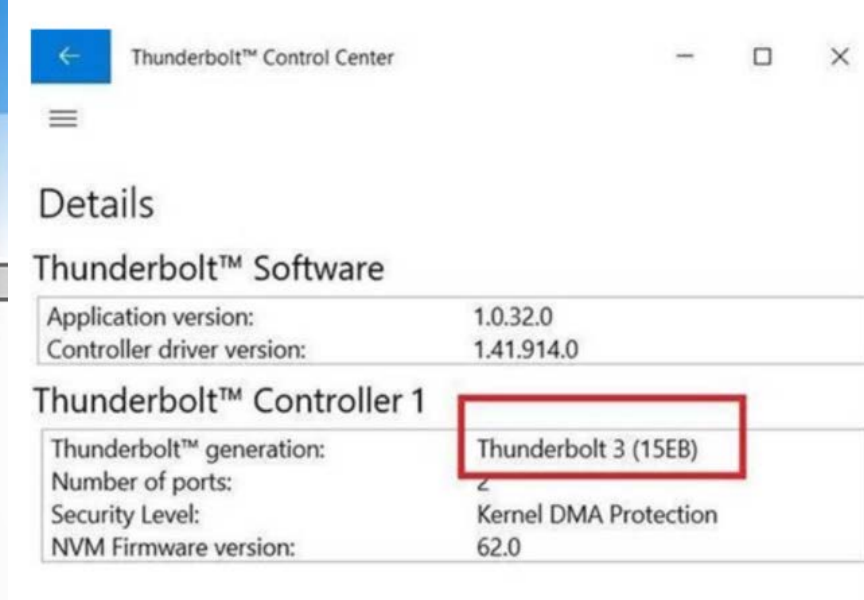
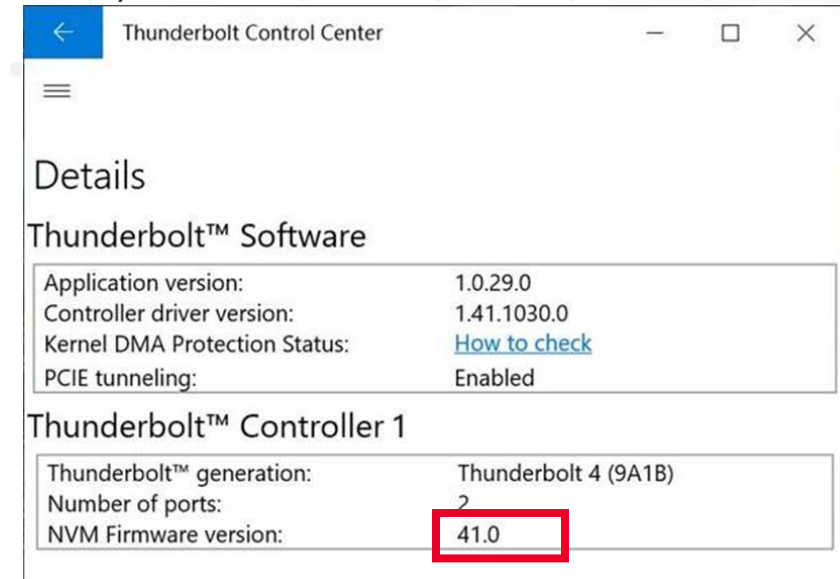
2. What is revision of Thunderbolt Control Center?

- Click “About”
- Check Thunderbolt generation and NVM Firmware (Thunderbolt firmware) version shown in dialog.

NVM Firmware version should be updated to **the latest version** by using a tool provided by PC vendors.

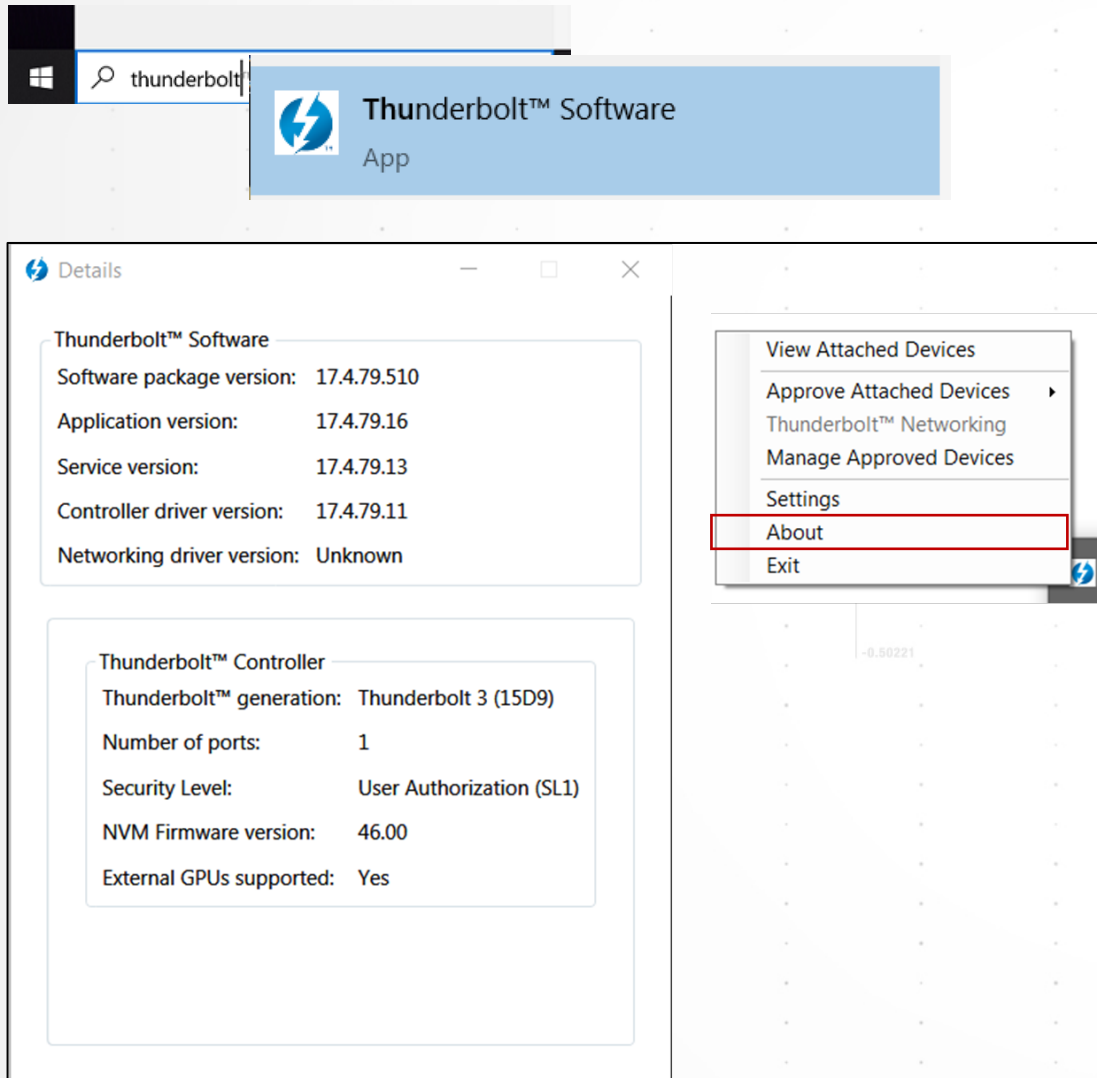
2. What is the revision of Thunderbolt Control Center?

- Launch Thunderbolt Software
- Right click on the system tray icon, click “About”
- Check Thunderbolt generation and NVM Firmware (Thunderbolt firmware) version shown in dialog.

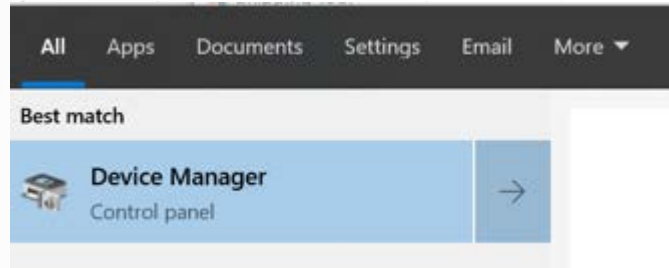
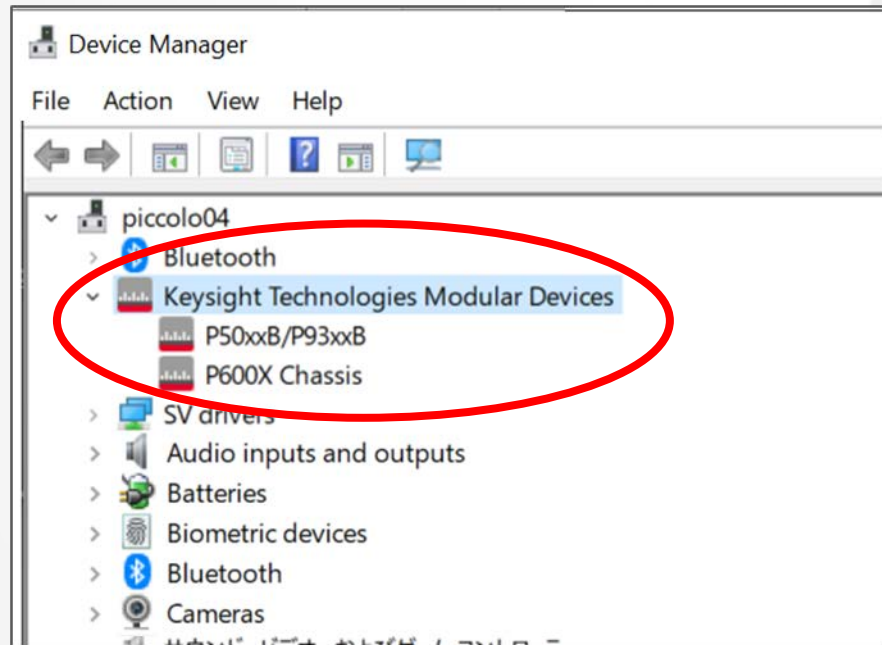
3. Is your VNA identified with Device manager? (Scenario #1)

- Type in “device manager” in the Windows search bar to launch Device Manager
- Confirm “P50xxB/P937xB” or “P600X Chassis” are shown in Device Manager.

If the model number of VNA (ex. P50xxB/P93xxB) and chassis (ex. P600xB) do not appear in Device Manager, BIOS, Thunderbolt firmware, or Thunderbolt driver with the host PC must be updated to the latest version.

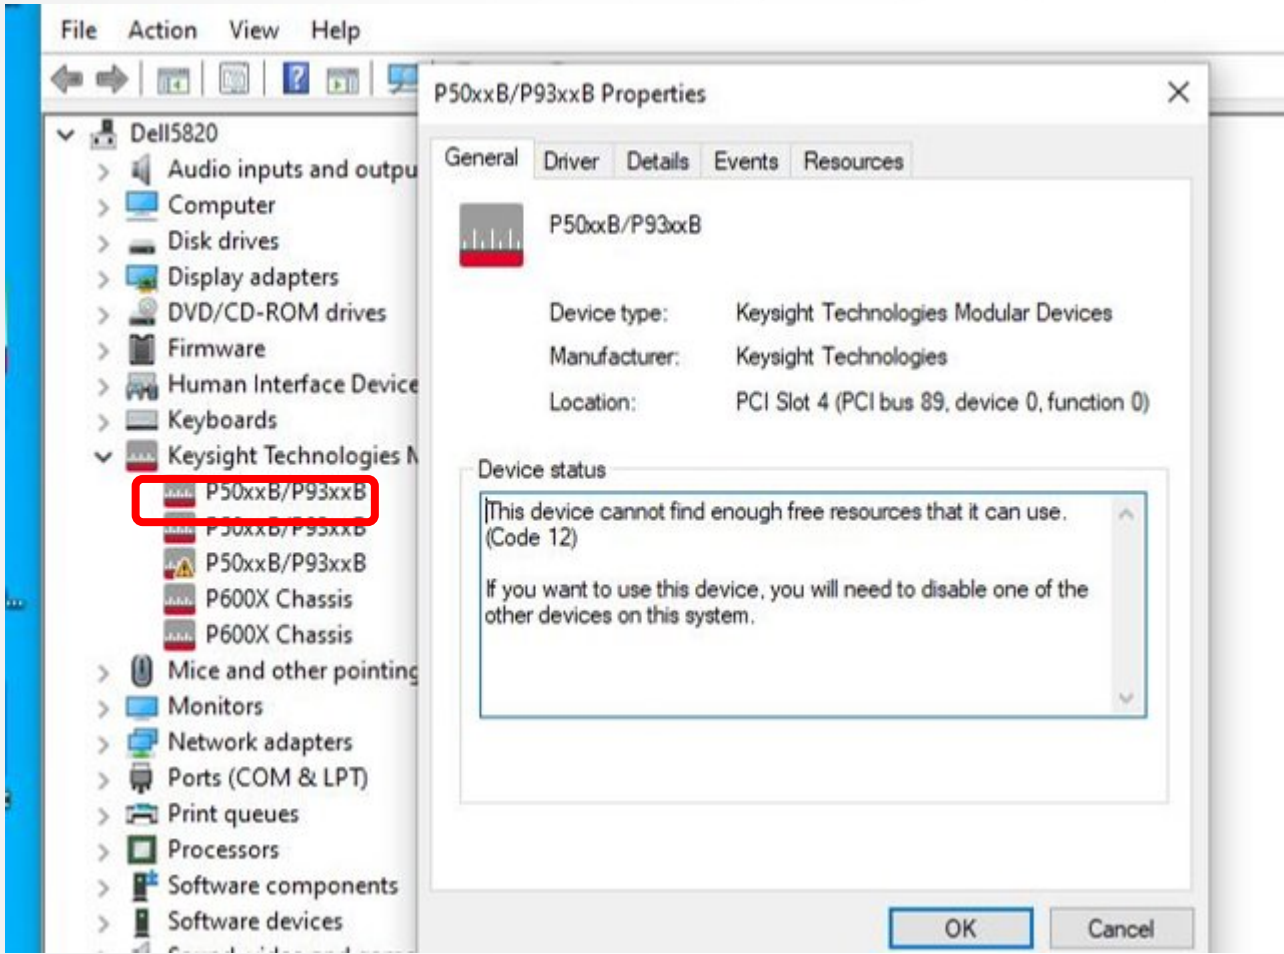
3. Is your VNA identified with Device Manager? (Scenario #2)

- Check Properties of P50xxB/P93xxB if “!” icon below is shown on your P50xxB/P93xxB.

Tips:
This icon appears when the host PC cannot allocate enough Kernel memory resources for PCIe communication within VNA. (VNA firmware cannot recognize the VNA).

1. Disconnect the second VNA (for two-VNA operations) or
2. Use another PC in the support list

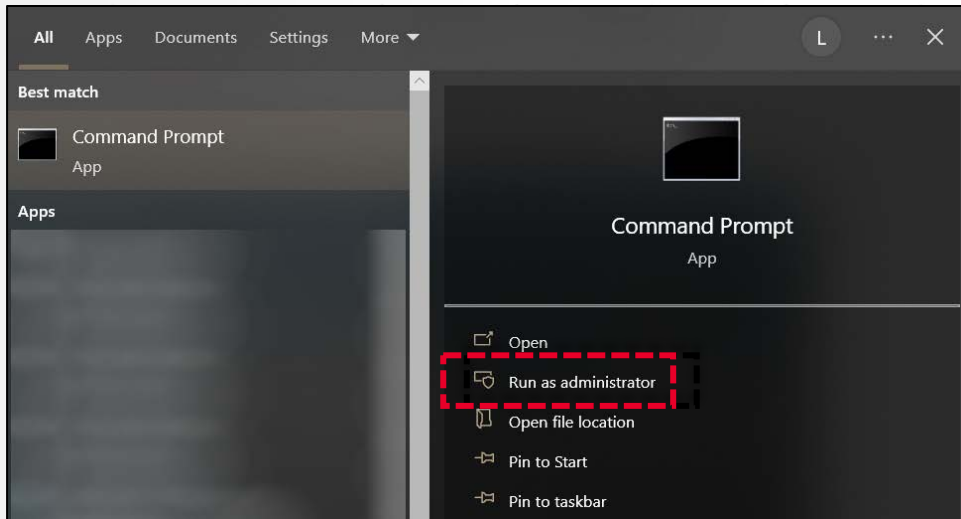
3. Is your VNA identified with Device Manager? (Scenario #3)

1. **Backup the current registry.** Launch Registry editor (regedit), select File> Export. Select ALL for Export Range. Enter file name (example original_reg_21June22.reg) and click save.
2. Download and unzip the TH_PCIE.reg registry patch to controller PC the VNA is connected to.
3. Launch Command Prompt in Administrative mode (Run as Administrator).
4. Navigate to the folder the registry file is saved to. Execute the patch with "reg import TH_PCIE.reg" command.
5. Launch Registry Editor. Ensure the HackFlags value is successfully added to the following \HKEY_LOCAL_MACHINE\SYSTEM\CurrentControlSet\Control\PnP\Pci

C:\Users\Desktop>reg import TH_PCIE.reg
The operation completed successfully.

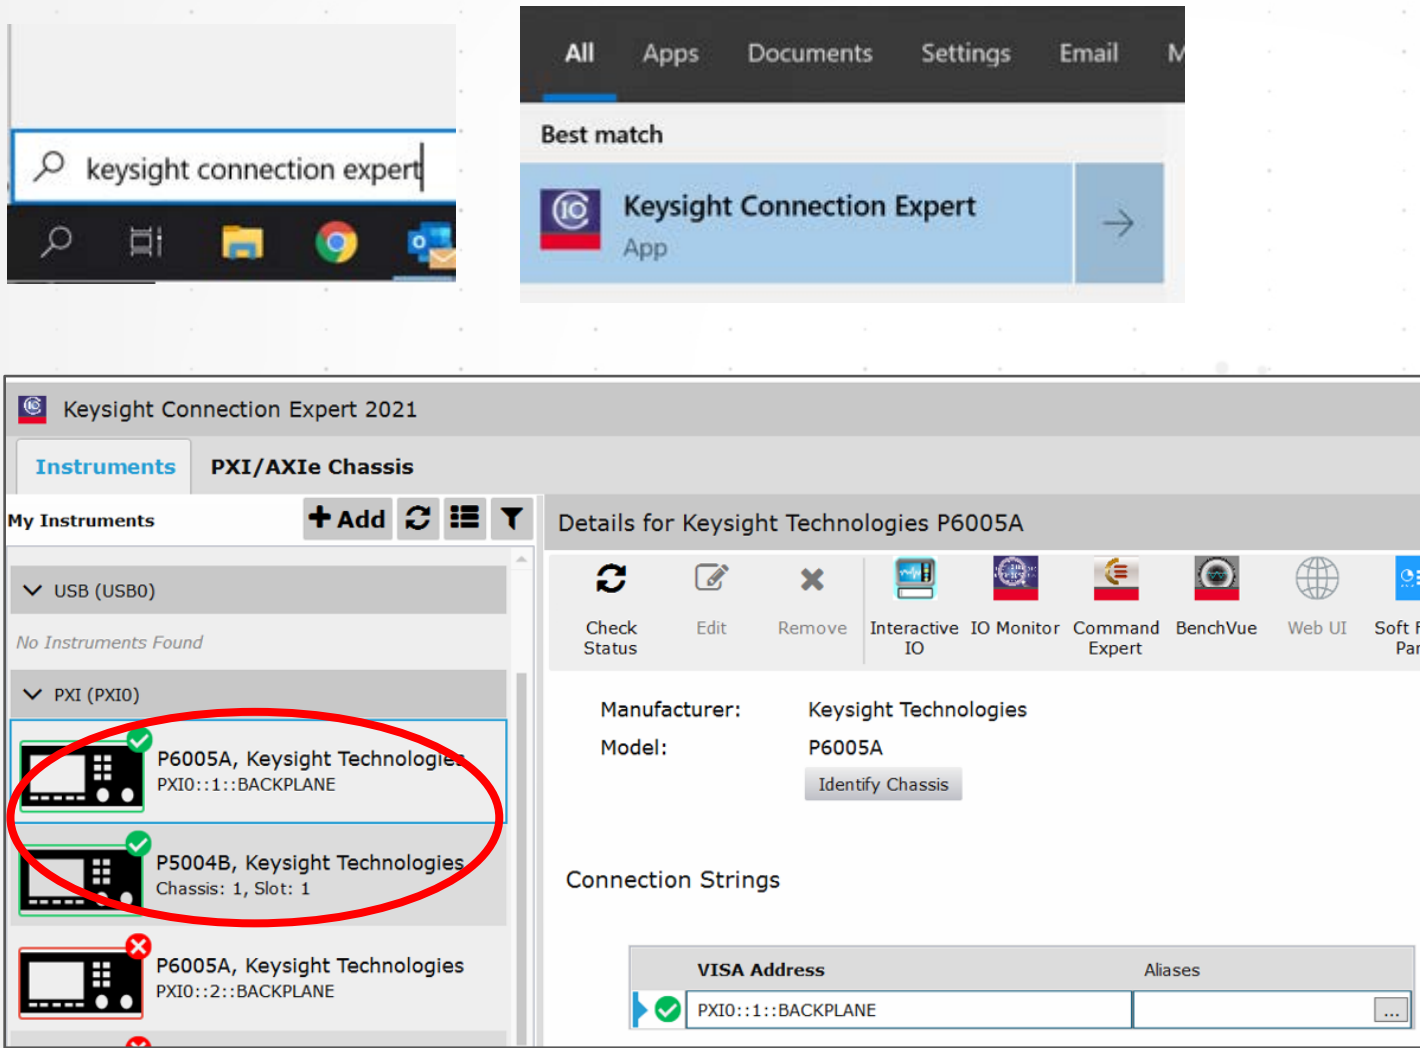
4. Is your VNA identified with Keysight Connection Expert?

- Type in “Keysight connection expert” in the Windows search bar to launch Keysight Connection Expert.
- Confirm “P50xxB/P937xB” or “P600X Chassis” are shown in Device Manager.

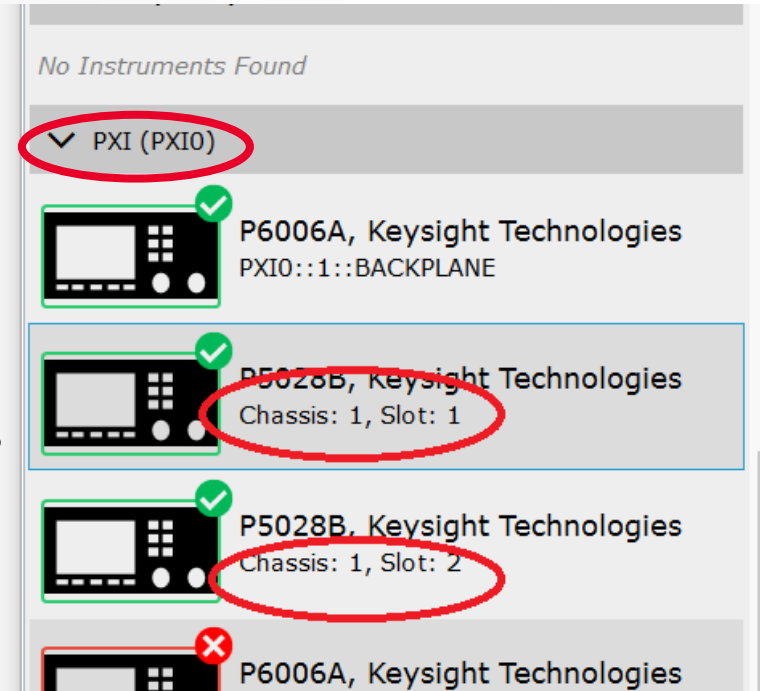
Successfully connected

Ex.) P5028B
Opt.402

- “P50xxB” (VNA model number) and “P6006A” (Chassis model number) should be displayed under “PXI (PXI0)”.
- “P50xxB” should be displayed with “Chassis: 1, Slot x”.

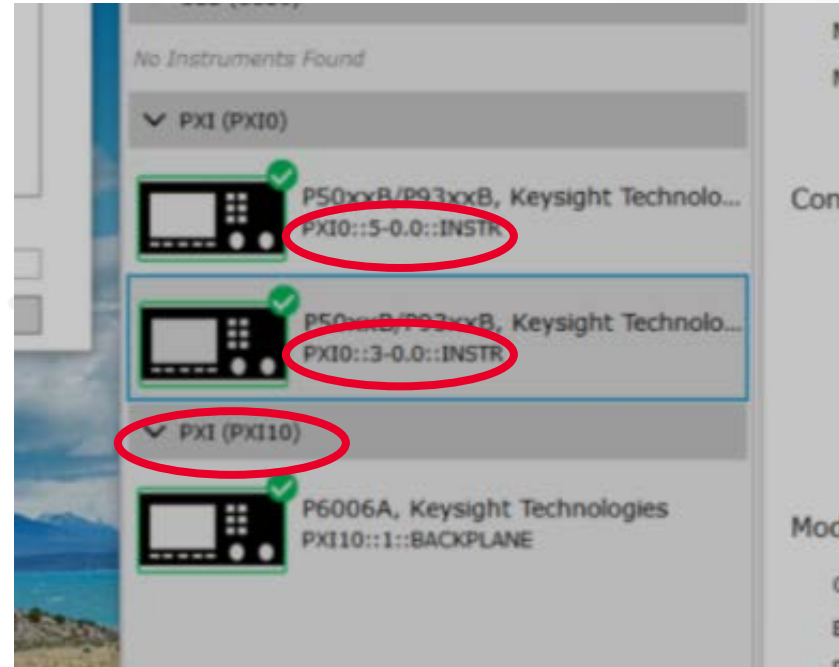
Connection failed

- “P50xxB/P93xxB” (VNA model number) is shown with “PXI0::x0.0::INSTR”
- “P6006A” (Chassis model number) is shown under “PXI (PXI10)”.

1. Reboot host PC.
2. Check “!” mark is shown in Device Manager (See Tips in 3. Is your VNA identified with Device Manager?).

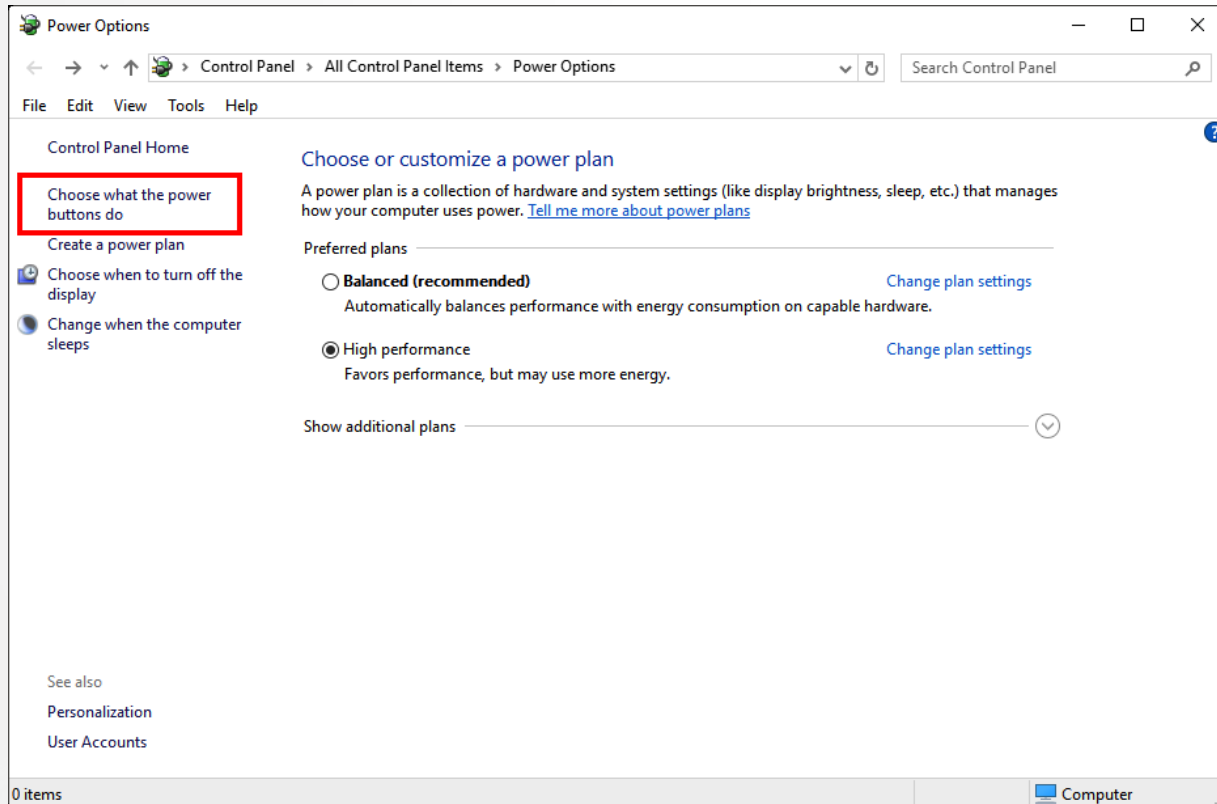
9. Is Windows 10 Fast Startup disabled?

- Press Windows key + R to bring up the run dialog. Type in “powercfg.cpl” and click “OK” to launch “Power Options”
- Click “Choose what the power buttons do” from the menu on left.

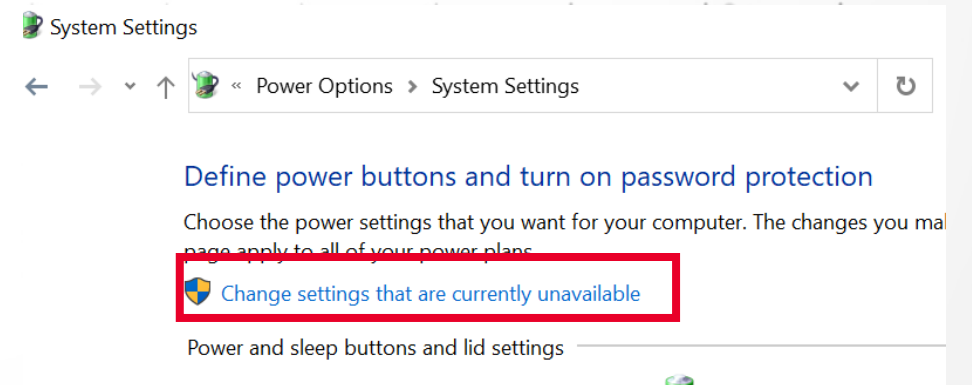
9. Is Windows 10 Fast Startup disabled?

- Scroll down to show “Shutdown settings” and uncheck the box of “Turn on fast startup”.
- Note: if these option are greyed out then you may need to click “Change settings that are currently unavailable”.

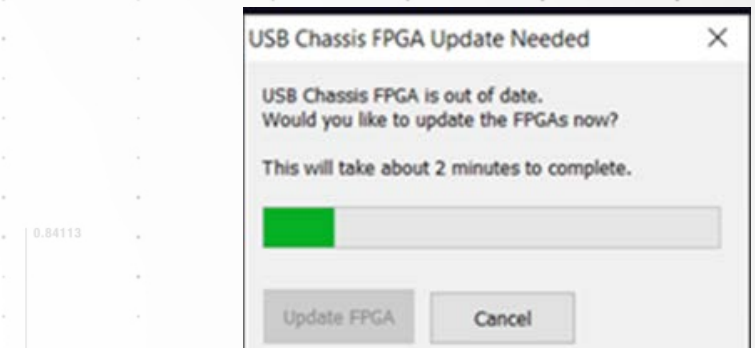
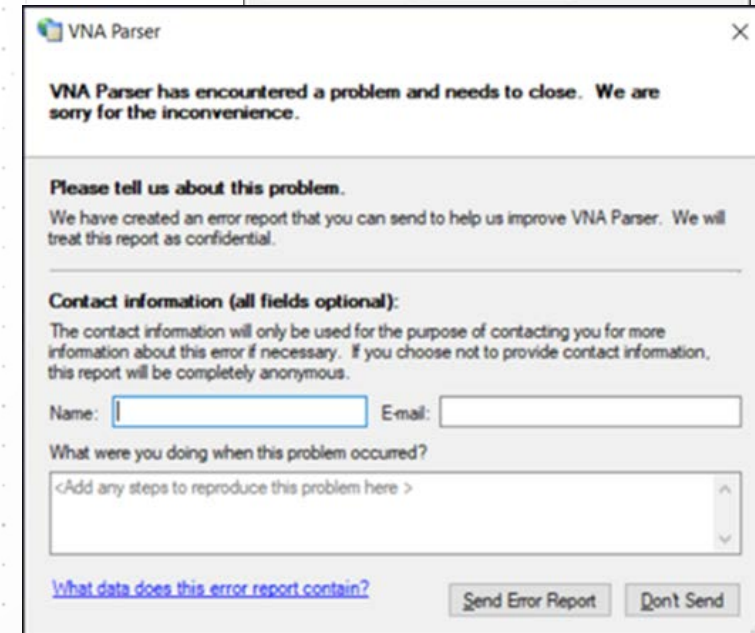
10. Is Thunderbolt 3 PCIe Hot plug mode in BIOS (UEFI) correctly set?

- Access to the BIOS (UEFI) settings page. In **Thunderbolt PCIe Hot plug mode**, select “Native + Low Power Mode”. Shown is the HP BIOS settings example.
- Note: if it is set to “Legacy Mode”, USB Chassis FPGA update will take a long time and fail to complete.

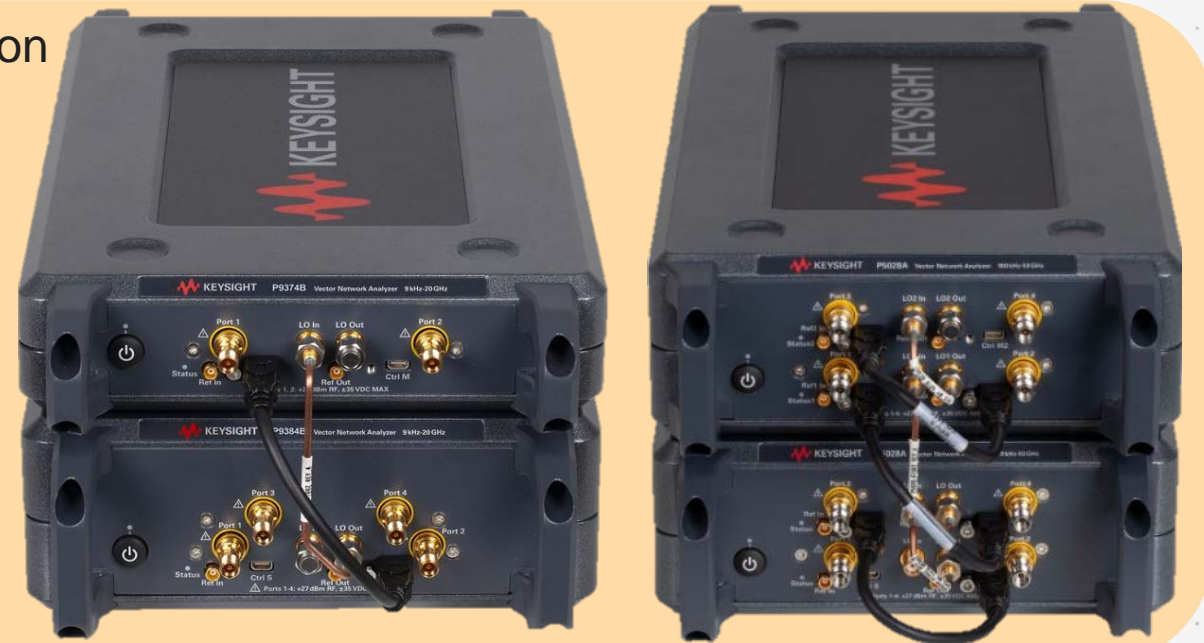
2 VNA operation

- When “Self test failure: Sweep timeout” error message is shown in Host PC, check interconnect cables for LO or control signal properly.
