Ramp Testing in Identifying and Preventing Insulation Failure

By Jeff Jowett

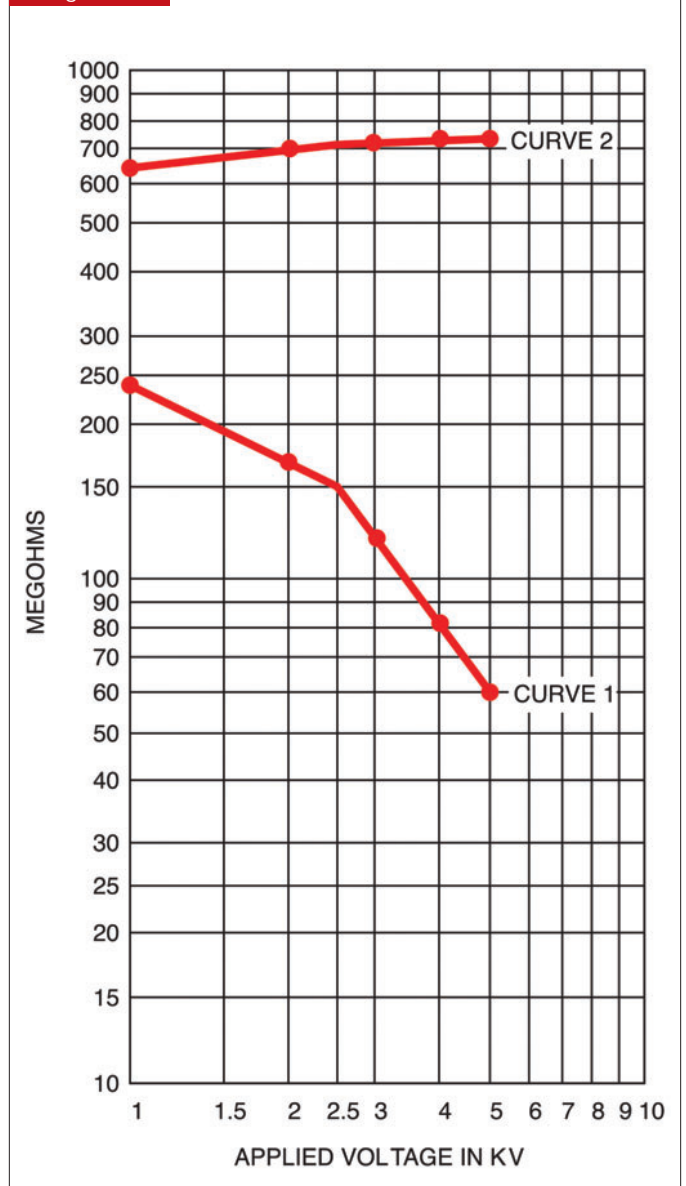
Figure 1

With insulation resistance testing, a general rule is that more than a 25% change indicates an excess of contaminants.

As the testers themselves have developed over the years, the implementation of this test has become simpler. As long as more than one test voltage is available, a simple Step Voltage Test can be performed manually. But modern testers have multi-voltage selection that reads directly, without having to adjust the reading to the voltage as was necessary with older models. Such units can easily perform the test manually, by turning the selector switch, noting the time and marking down measurements. Even more advanced megohmmeters do the whole thing automatically. Typically, only the voltage ceiling need be selected and the Step Voltage mode engaged, and such models will run the test automatically, displaying all relevant data at the conclusion. Accordingly, an industry-standard procedure has evolved where five successive voltages are applied for one minute each. If a 5 kV ceiling is selected, the test will run at 1, 2, 3, 4, and 5 kV for one minute each, a total of a five-minute test. As always with insulation resistance testing, comparison to previous results is the best evaluation, but for sake of perspective, a general rule is that more than a 25% change indicates an excess of contaminants (Fig. 1).

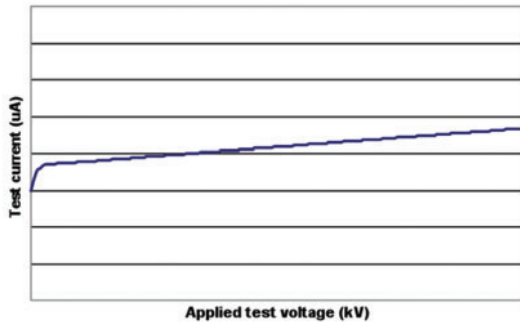
Figure 2

Typical ramp test result for epoxy-mica insulation

The evaluation of test results first prescribes that insulation in good condition should produce a smooth, almost linear rising current curve against the applied voltage. Any deviation should be viewed as a warning that the test could be approaching a possible breakdown. A sudden increase in current usually indicates imminent breakdown, and it has been possible to approach as closely as 5% below breakdown voltage. An abrupt drop in current is rare, but if it occurs when test voltage is above peak operating voltage, it can also be an indication of imminent breakdown. Comparing the curves of asphalt-mica to epoxy-mica shows that asphalt-mica has a higher level of absorption current, resulting in a steeper curve. But both produce clean, linear graphs when in good condition (Figs 2 & 3).

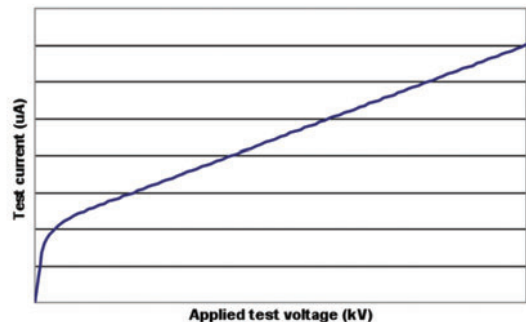
Figure 3

Typical ramp test result for asphalt-mica insulation

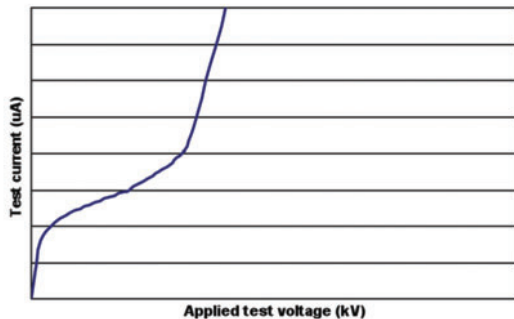
Figure 4

Typical ramp test showing moisture ingress

By contrast, insulation having absorbed moisture produces a sharp rise in current, and the test would have been stopped (Fig. 4). Old asphalt may produce a slightly non-linear response showing small deviations as “blips”, whereas significant localized weaknesses will show a sudden, larger increase (Fig. 5). The test would be terminated as the graph approached vertical. Cracks in ground wall insulation will show a sudden near-vertical rise, often preceded by small spikes (Fig. 6). It is also useful to compare the current curves from different phases.

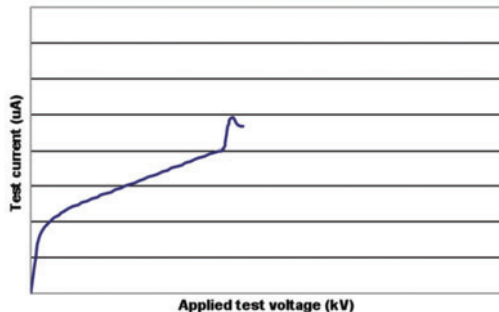
Figure 5

Asphalt-mica insulation with localized weakness

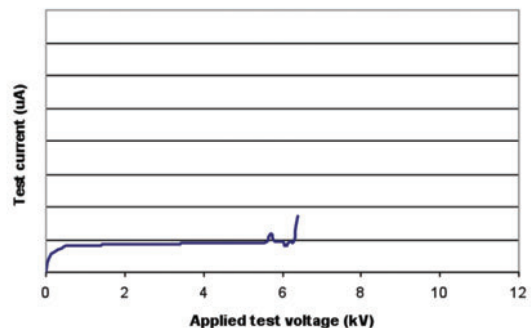
Figure 6

Epoxy-mica winding with cracked insulation
