# TiX560/TiX520 Inspection Guidebook

# INFRARED INSPECTION APPLICATIONS

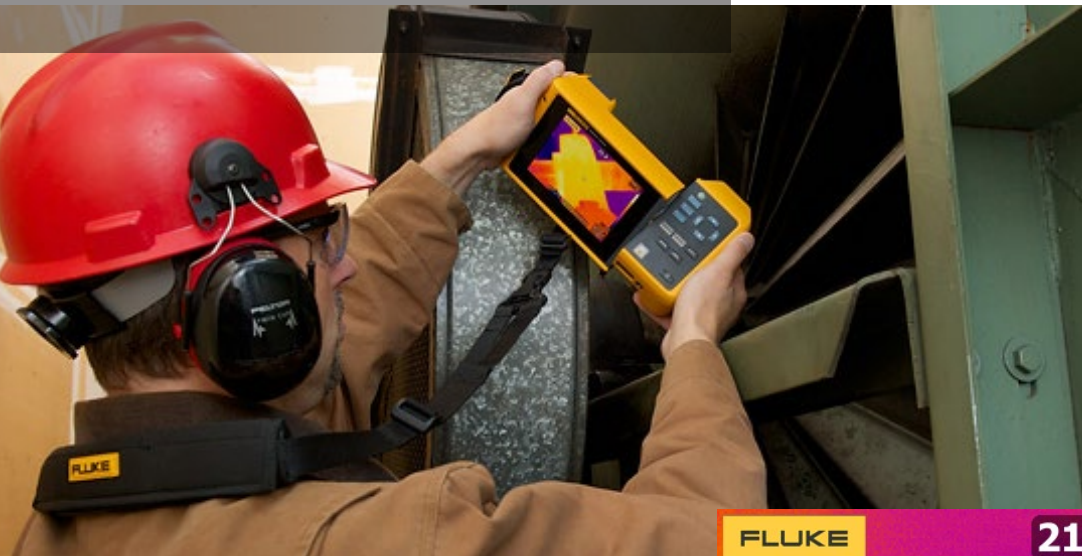
**Find hot bearings fast with a high resolution infrared camera with articulating lens**

Overheated bearings can cause machinery to fail resulting in a sudden interruption of the production line. Replacing those bearings can be costly both in terms of materials and downtime. To extend bearing life, they should be regularly inspected for wear and overall health. But before you shut down the production line or motor to perform that maintenance, you can quickly scan bearings with an infrared camera to prioritize those that need service first.

Because bearings have to be inspected while in use, an infrared camera is an ideal non-contact inspection tool. It enables you to detect the running temperature of bearings quickly, from a safe distance. That way you can find overheated bearings before they cause failures, or excess strain on motors.

Overheated bearings are typically found by comparing the surface temperature of a suspect bearing to an adjacent bearing of the same type under the same load. Overheating can be caused by too much or too little lubricant, incorrect mounting or incorrect replacement bearings. Using a TiX5xx camera you can stand at a safe distance from the target

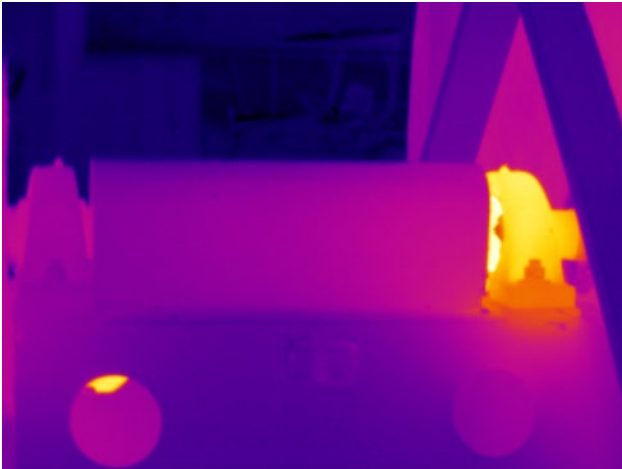
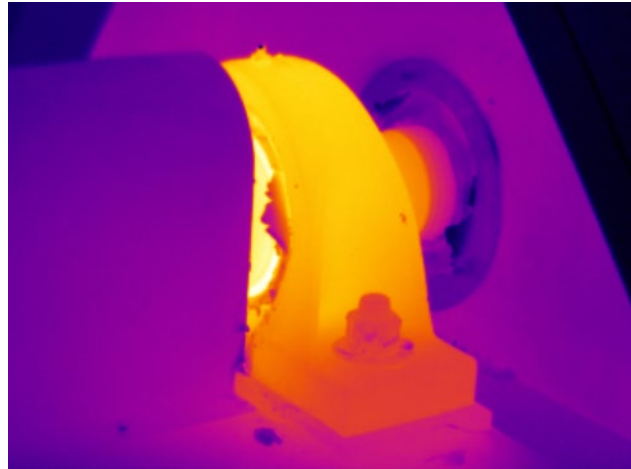
With the TiX560 you can clearly see that the right side of the bearing has an issue.

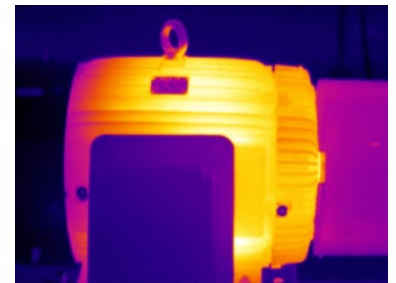
### Extend motor service life with infrared inspection

Motors take a lot of abuse in today's manufacturing and process plants. They are costly to replace, so preventive maintenance is critical to keeping them in top operating condition and extending their service life. Overheating is one of the biggest factors in shortening that life. Operating at a temperature of ~10° over its rated value can cut in half the service life of a motor. Therefore, regularly checking motor operating temperature is crucial to ensuring reliable operation of production systems.

An infrared camera can help you find overheating in a running motor so you can address the problem before the motor is damaged. Fluke TiX560 and TiX520 Expert Series infrared cameras make it even easier with their 180° articulating lens that you can aim at the motor from above, below, or sideways. With the large 5.7 inch touchscreen you can view your target straight on before capturing the image. The high resolution (up to 640 x 480 on the TiX560), excellent thermal sensitivity, LaserSharp® Auto Focus, and other enhancements included in Fluke TiX5XX infrared cameras help to ensure that you get clear crisp images from a safe distance.

Poor lubrication or misalignment of mechanical components can cause motor bearings and couplings to overheat and vibrate, which can put undue stress on your motor and lead to early failure. With Fluke TiX5XX cameras you can quickly zero in on overheated pillow block bearings, and maintain or replace them before they add stress that can damage the motor and result in much higher repair or replacement costs.

A short-circuit in the internal iron core or winding of the motor due to aging insulation or insufficient ventilation can cause motor casings to overheat. Although you can't see the inside of a motor with an infrared camera you can find an indication of a problem by detecting an above-average surface temperature on the motor.

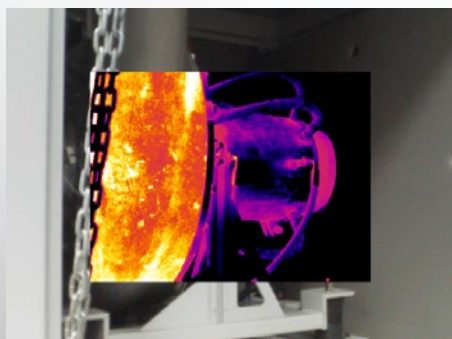
Identify the extent of the problem and exact location with AutoBlend™ and picture-in-picture.

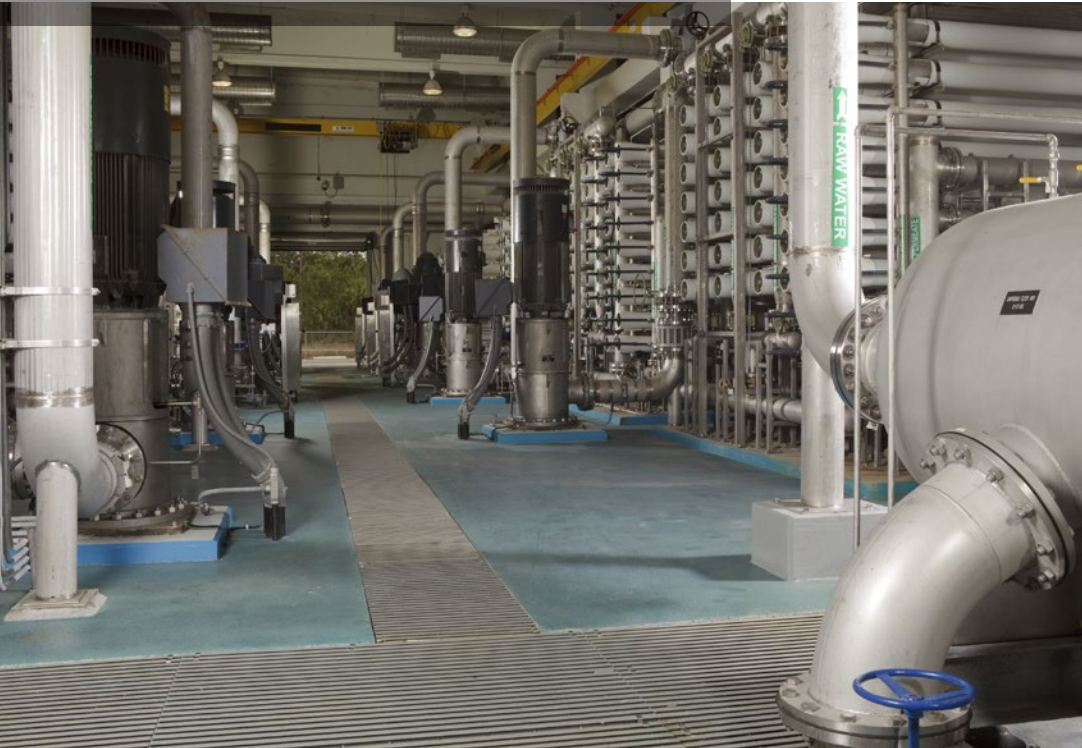
## Using infrared cameras to find pipe blockages

Whether they carry liquid product, water, steam, natural gas, or oil, keeping pipes flowing smoothly is critical to safe and efficient manufacturing and processing systems. Blockages, thinning, and corrosion can diminish the efficiency and safety and result in leaks that could cause serious damage to your facility and your people.

The challenge is to find problems such as carbon deposition, thinning, and cracking in hundreds or thousands of feet of pipe, as well as leaks and clogs in heat-exchanger and reactor tubes. A high resolution infrared camera (also called a thermal imager) can expedite inspection of this equipment and provide the thermal detail to detect small temperature changes that can aid early detection of potentially big problems.

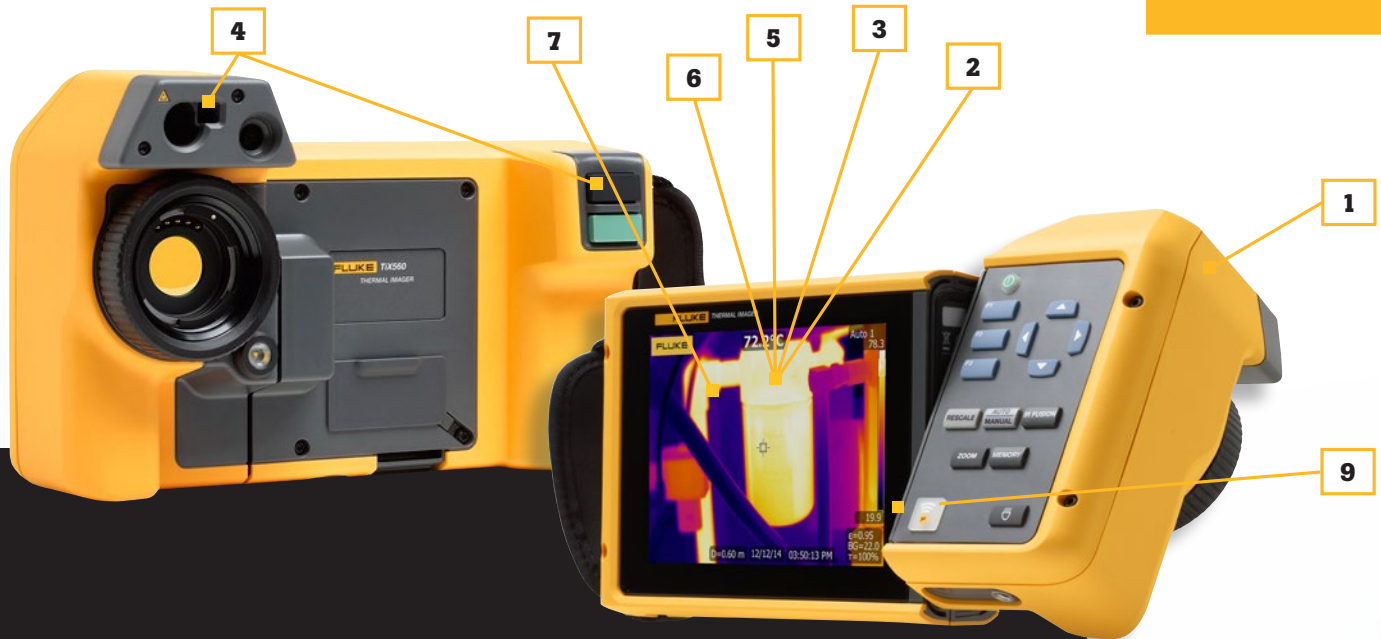
- 1 **Ergonomic 180° articulating lens** gives you maximum flexibility and makes it easy to navigate over, under, and around objects so you can see the image before you capture it. It allows you to verify that the image is in focus before you record it, unlike a pistol-grip camera that can be very difficult to focus when you're in an awkward position. This allows technicians to work in more ergonomically agreeable positions for all day use.

- 2 **The only 5.7 inch responsive touchscreen** in its class<sup>1</sup> delivers 150%<sup>2</sup> more viewing area to make it easy to see even subtle changes and details right on the camera. Quickly finger scroll through saved thumbnail images on the screen, zoom in and out, and access shortcuts to save time and increase productivity.

- 3 **Enhanced image quality** and temperature measurement accuracy allow you to increase 320 x 240 images to 640 x 480 in SuperResolution mode to find subtle anomalies faster.

- 4 **LaserSharp® Auto Focus** at the touch of a button takes the guesswork out of precision focus. The built-in laser distance meter calculates the distance to your designated target and then automatically focuses to produce the optimum image.

- 5 **Image Sharpening** reduces fixed pattern noise to create sharper images, particularly in high temperature environments. (On TiX560 only)
- 6 **Filter mode** achieves Noise Equivalent Temperature Difference (NETD) as low as 30 mK to detect very slight temperature differences.

- 7 **Hot and cold spot markers** highlight the hottest and coldest pixels on the image and displays their temperature values at the top of the screen for quick identification of anomalies.

- 8 **On-camera storage, editing, and analysis** allow you to store thousands of images in memory and bring them up in the field to edit, add digital images, text or voice annotations, and analyze right on the camera.

- 9 **Fluke Connect™** wireless compatibility enables you to see, save, and share live video, still images, and measurements with team members who have the Fluke Connect™ mobile app on their smart phones. Just push the shortcut button to connect.

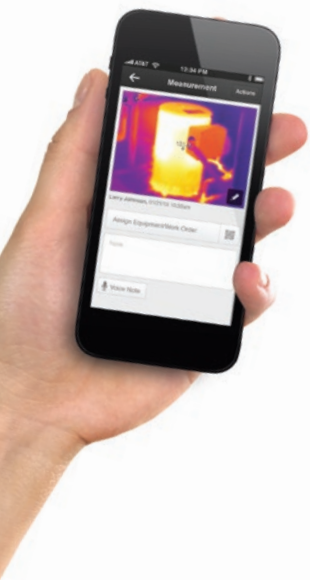
**See and share more results at one time with Fluke Connect™ wireless capabilities**

The Fluke TiX560 and TiX520 cameras are Fluke Connect-enabled so you can transmit images and measurements from the cameras to smart phones or tablets that have the Fluke Connect\* mobile app. In so doing you can share results with authorized team members and thus enhance collaboration and help resolve problems faster.

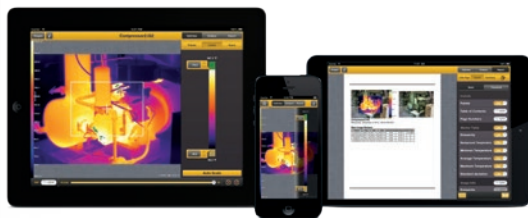
With SmartView® software, included with Fluke infrared cameras, you can run additional analyses and document findings in reports that include thermal and visible light images, and measurement data. You can adjust most parameters on the stored image, including emissivity, color palette, and level/span, just to name a few.
